USDA FOREST SERVICE  
RESEARCH PAPER INT-97  
1971

# INVESTIGATION OF SLOPE FAILURES IN THE IDAHO BATHOLITH

M. J. Gonsior and R. B. Gardner

INTERMOUNTAIN FOREST AND RANGE EXPERIMENT STATION  
Ogden, Utah 84401

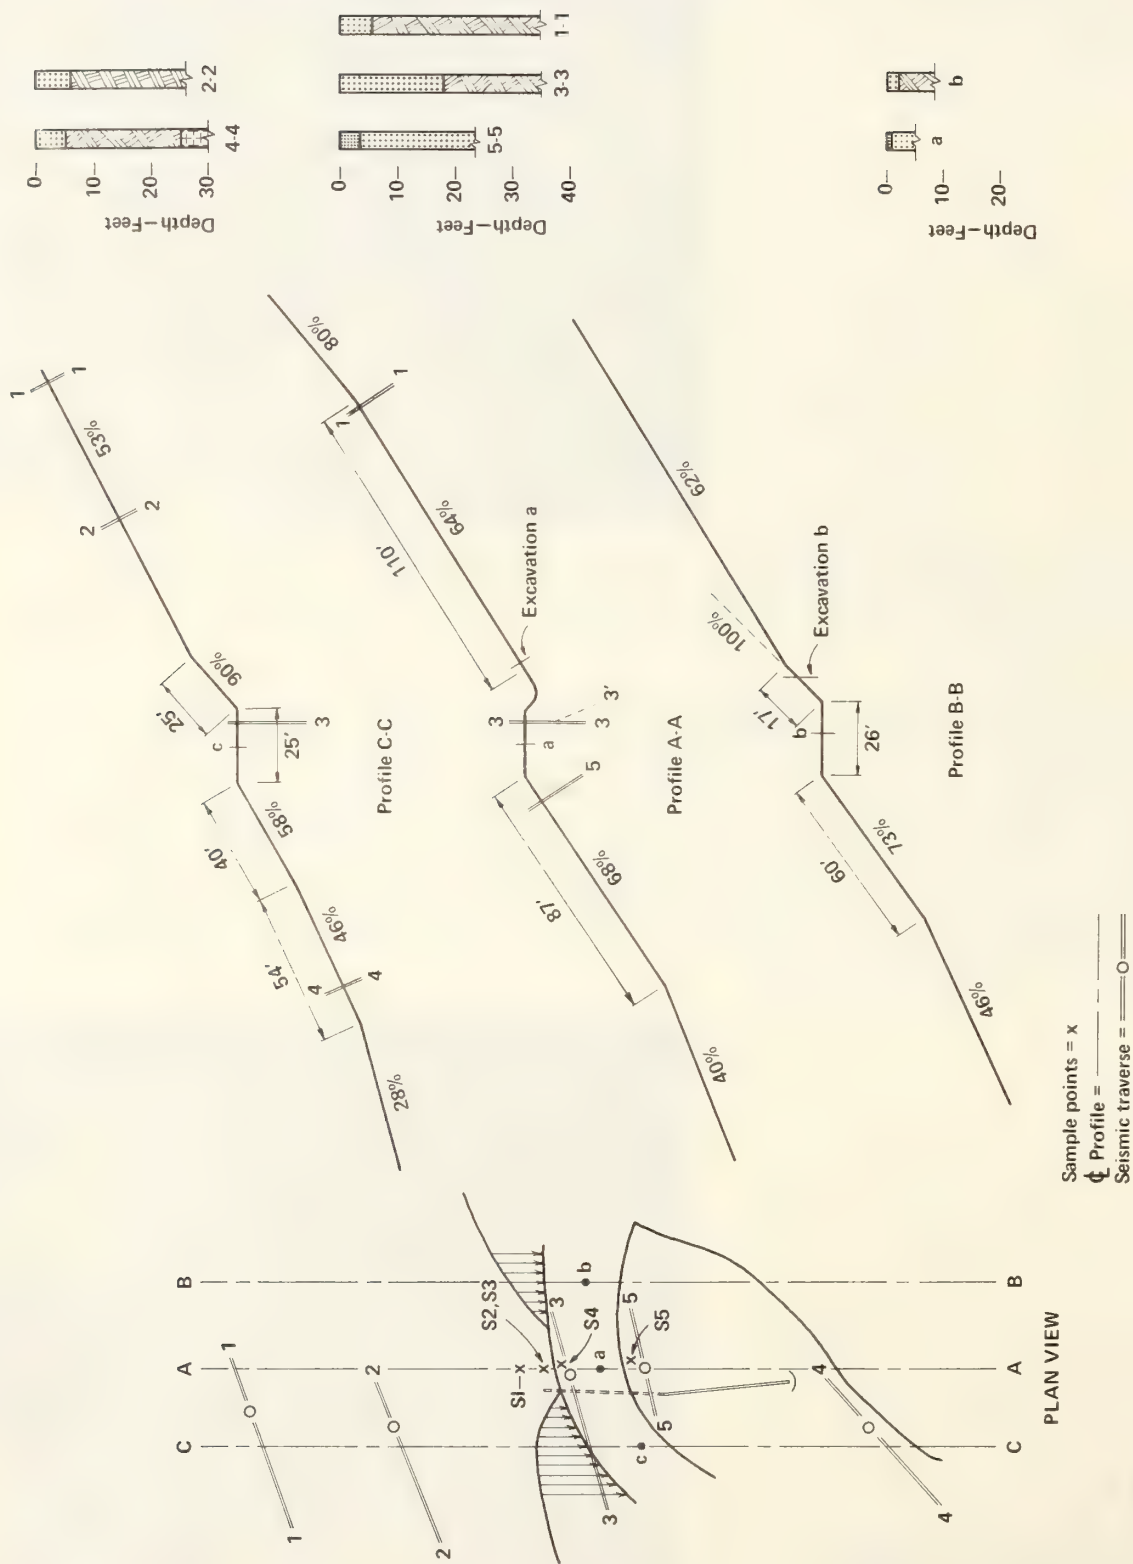
Figure 15.--Description of test site 917-1.

Five seismic traverses were run at site 917-1; the approximate locations are shown in figure 15. The small circles on the double lines represent the approximate locations at which the seismic interpretations are valid. Following are the interpretations, with the accompanying seismic velocities included:

Also shown in figure 15 are the approximate test pit locations.

Lines A-A, B-B, and C-C in the figure are the locations of the profiles sketched adjacent to the plan view in figure 15.

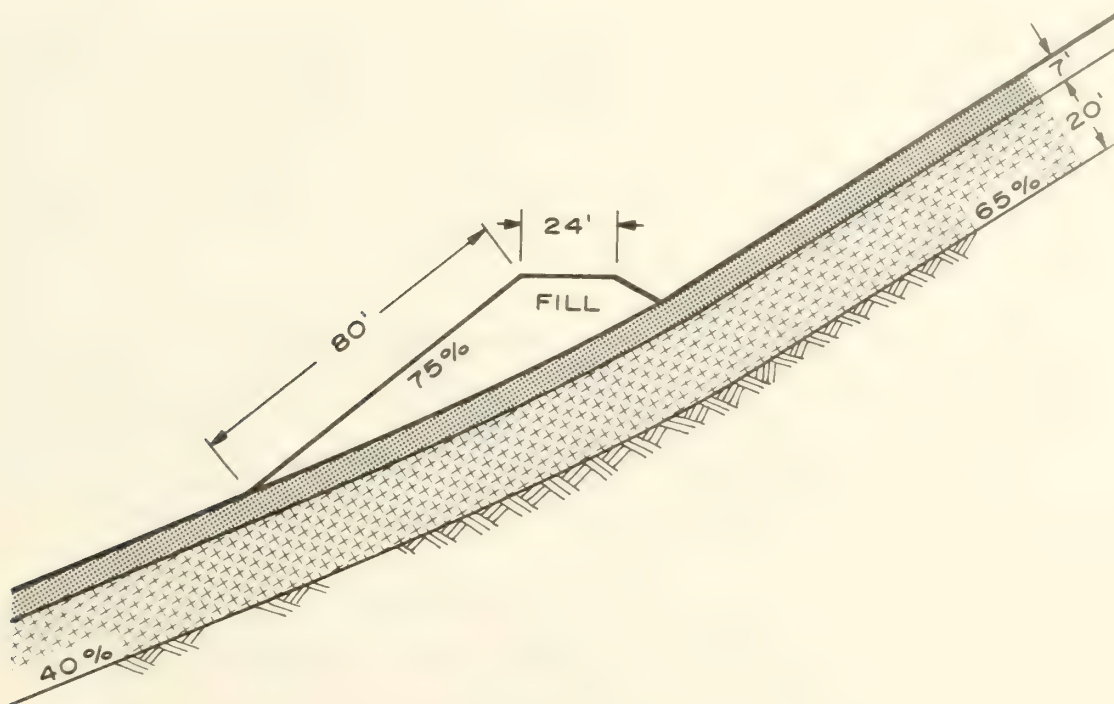
Figure 16.--Representative profile, site 917-1.

Based upon the data available, a representative profile of this site is shown in figure 16.

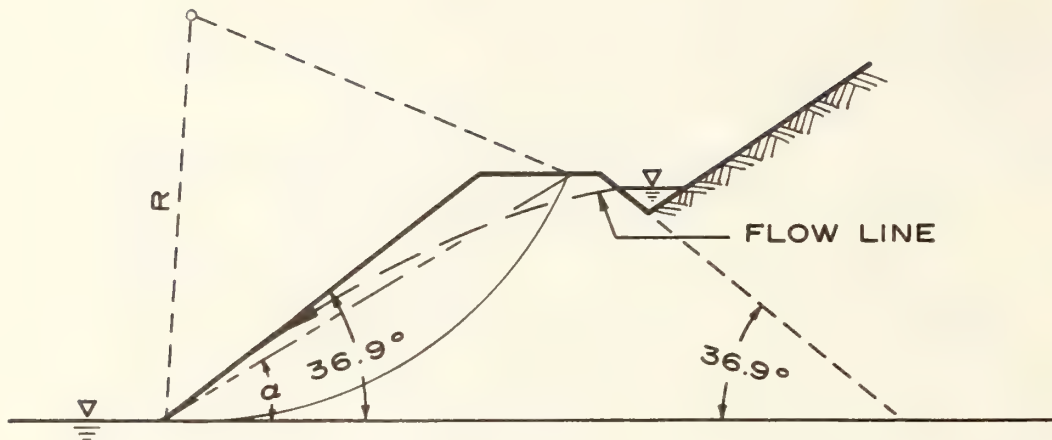
Figure 17.--Assumed conditions for L. Casagrande solution at site 917-1.

A conservative analysis can be performed by assuming a plugged culvert and subsurface flow as shown in figure 12. In this analysis, the L. Casagrande solution for the top flow line through a triangular dam is used<sup>2</sup> (see Taylor, p. 181). It is arbitrarily assumed that the upstream and downstream slopes of the dam are equal. Figure 17 depicts the assumed cross section.

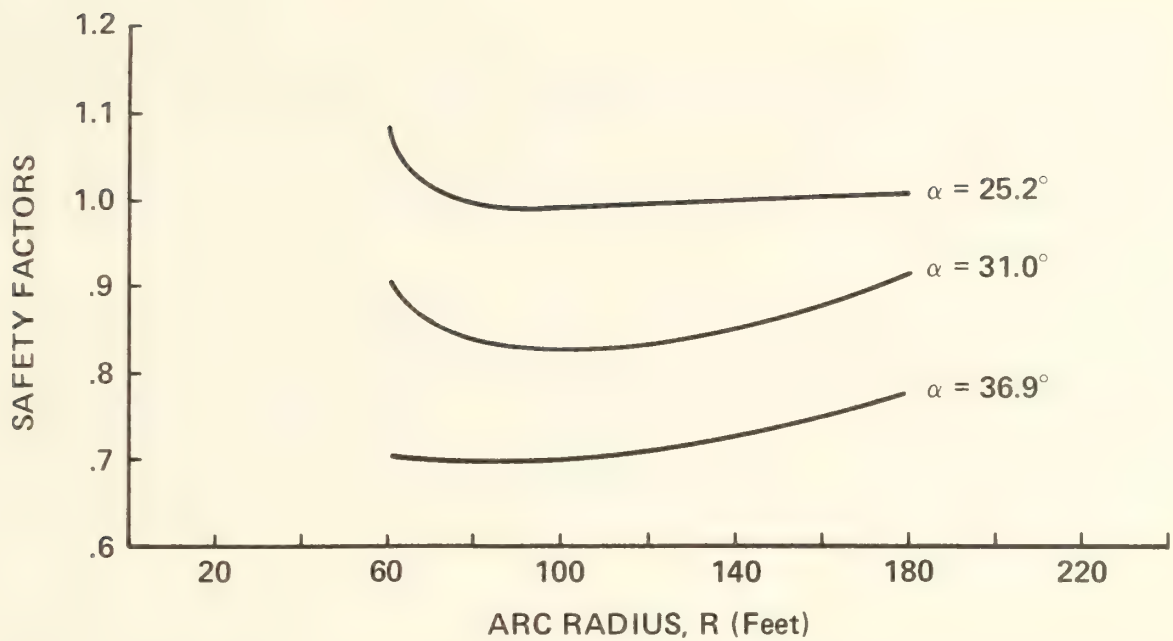
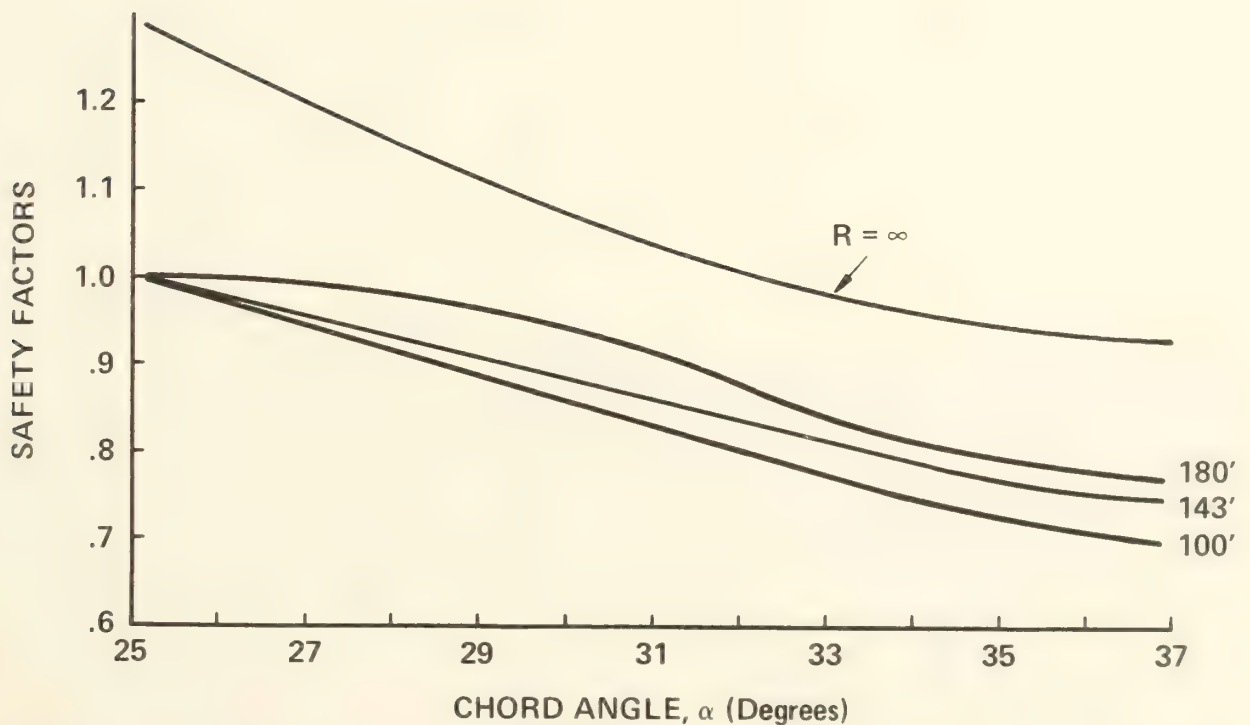
A series of analyses were conducted, assuming circular failure arcs and using the method of slices. In all cases, failure arcs were assumed to pass through the toe of the fill slope. The material above the top flow line was assumed to weigh the same as that below the top flow line, or 134 p.c.f. The results of these analyses, assuming that  $c = 0$  and  $\phi = 35^\circ$ , are shown in figure 18 and, alternatively, in figure 19, wherein the parameters  $R$  and  $\alpha$  are as shown in figure 17. Safety factors significantly lower than 1.0 are noted in figures 18 and 19. Three major conclusions can be drawn from these analyses:

- (1) The assumed friction angle of  $35^\circ$  may be too low.
- (2) The material actually possesses a minimum cohesive strength, even when saturated.
- (3) The assumed seepage conditions are significantly more severe than would ever arise naturally.

Figure 18.--Safety factors vs. arc radius,  $R$ , for conditions given in figure 17.

Figure 19.--Safety factors vs. arc chord angle,  $\alpha$ , for conditions given in figure 17.

Although the effective friction angle in the field may exceed  $35^\circ$ , it is believed that the angle stated in the first conclusion is a reasonable estimate based upon the consistency of the laboratory results. Further, where the safety factors are as low as 0.7, a friction angle of  $45^\circ$  would be necessary in the absence of cohesion to increase the safety factor to 1.0. It seems inconceivable that the estimate of the friction angle would be this much in error.

With regard to the second conclusion, it seems possible that this material may possess sufficient cohesive strength, even when saturated, to assure stability at this site. The computed maximum cohesion required for a safety factor of 1.0, among all of the trial failure arcs, was only 175 pounds per square foot (p.s.f.), or about 1.2 pounds per square inch (p.s.i.), assuming  $\phi = 35^\circ$ . Thus, although it has been concluded that no cohesive strength should be used for design purposes, it must be recalled that even in the saturated triaxial tests on loose material, a cohesive strength of 1 p.s.i. was estimated. Obviously, therefore, some moderate cohesion, combined with a slightly greater estimate for the friction angle, would assure computed safety factors in excess of 1.0 for all the trial failure arcs in this analysis.

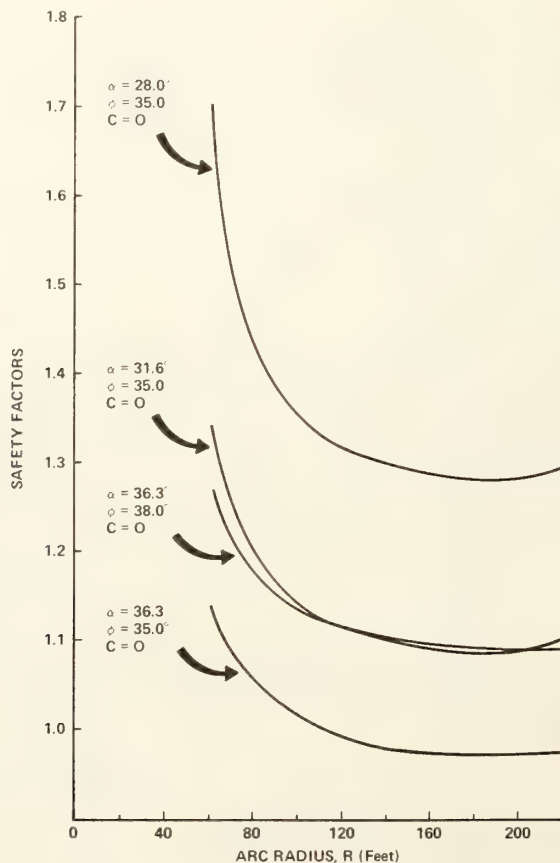
Figure 20.--Safety factors vs. arc radius,  $R$ , without seepage for site 917-1.

The third conclusion is undoubtedly correct. There is no evidence that the culvert has ever become plugged at site 917-1. Even in the event of such an occurrence, it is doubtful that a stable seepage condition as severe as that assumed in these analyses would arise. However, since the exact flow pattern cannot be predicted, a series of analyses were conducted assuming no seepage. This was done in order to establish a minimum upper limit for the safety factors at this site. The results of these analyses are shown in figure 20, where the parameters  $R$  and  $\alpha$  are as defined in figure 17.

Again, it is noted that either the friction angle ( $\phi$ ) or cohesion ( $c$ ) has been underestimated, since safety factors less than 1.0 were calculated. In these analyses, an estimated cohesive strength of 1.0 p.s.i., or 144 p.s.f., would have resulted in a minimum computed safety factor of approximately 1.4.

To evaluate the influence of error in the estimate of  $\phi$ , a series of analyses, again assuming no seepage, were conducted with  $\phi = 38^\circ$ ,  $c = 0$ , and  $\alpha = 36.3^\circ$ . The resulting safety factors are shown in figure 20. Thus, only moderate increases in either  $\phi$  or  $c$ , or in both  $\phi$  and  $c$ , result in computed safety factors indicating stability.

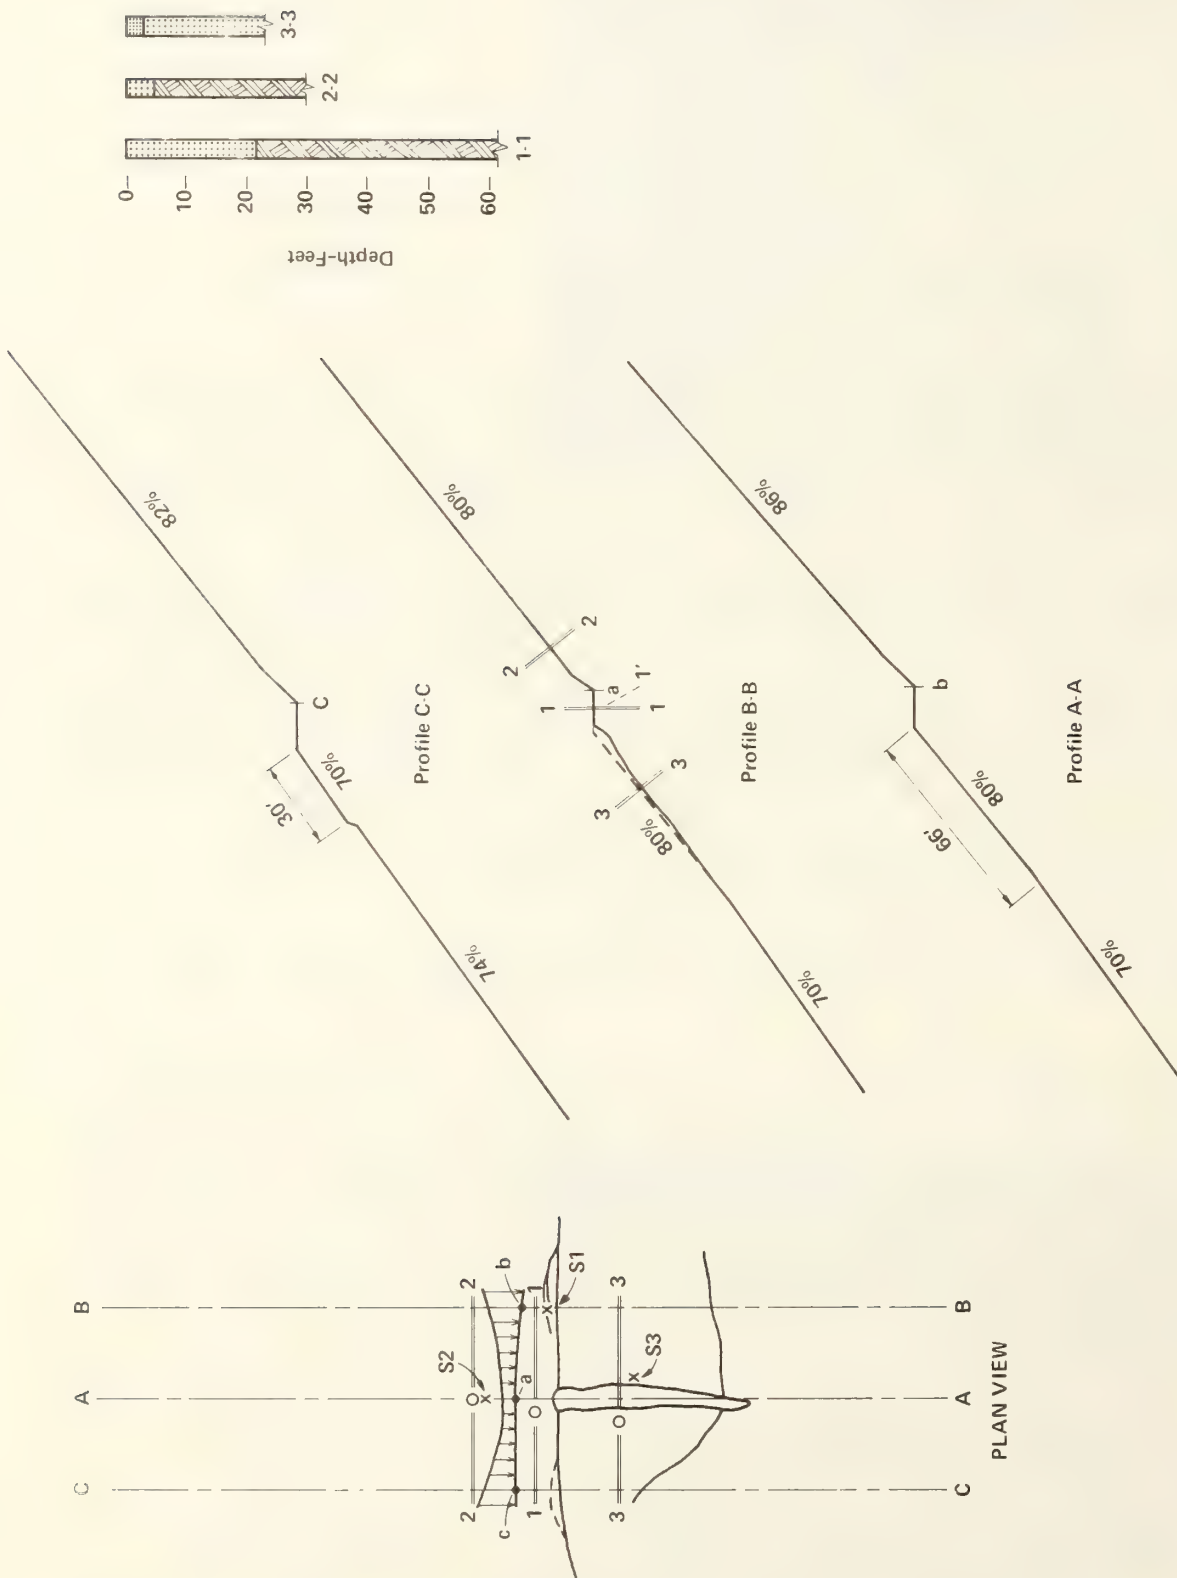
Figure 24.--Description of test site 917-3.

Plan view and profile sketches appear in figure 24, along with pertinent seismic profile and test pit information.

Apparently the incipient failure surfaces, as is the scar left by the narrow failure, are at relatively shallow depths below the fill slope. Ignoring for the moment any water infiltrating from the road surface, the ground water conditions represented by figure 11 would seem to have minimal influence in the outer portion of the fill where failure occurred and is impending. To evaluate the accuracy of the laboratory estimates for  $\phi$  and  $c$ , a series of analyses were conducted assuming circular failure arcs, with an assumed saturated unit weight of 125 p.c.f., but without excess boundary neutral stresses along the failure arc. (From table 2, test pits 917-3-1 and 917-3-3, an average dry unit weight of 100 p.c.f. and  $e = 0.66$  provides for a saturated unit weight of 125 p.c.f.). The analyses were made under the condition that all failure arcs passed through the toe of the fill slope, where the fill slope was 70 feet in length and at a slope of  $38.6^\circ$  (profile A-A).

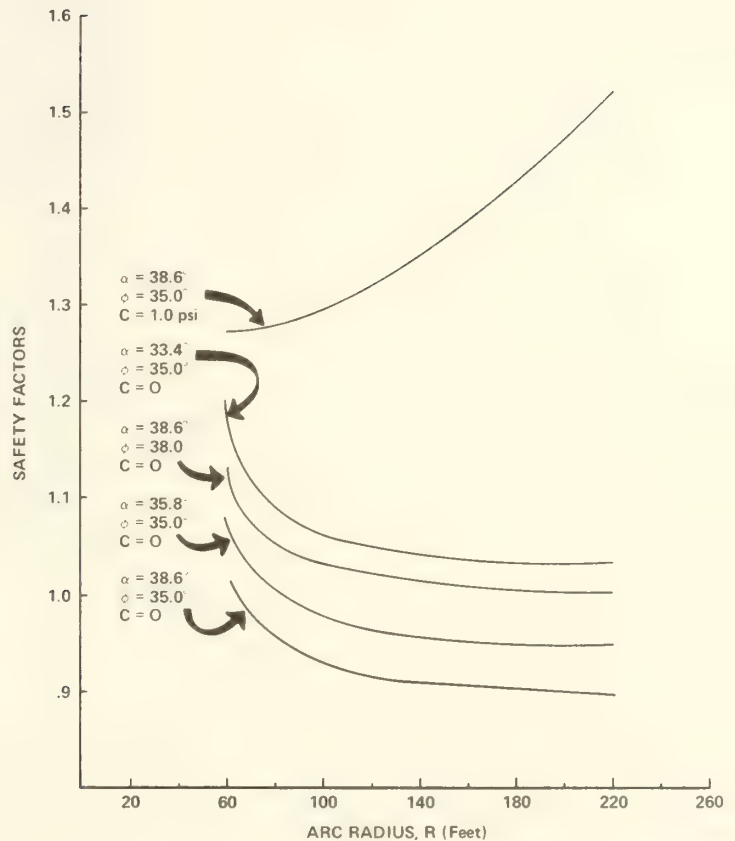
Figure 25.--Safety factors vs. arc radius,  $R$ , for site 917-3, with zero boundary neutral stresses.

Finally, a series of analyses were conducted with  $\phi$  increased to  $38^\circ$  and  $c = 0$ . The results of these analyses are also shown in figure 25, and seem to be most compatible with the observed conditions at the site.

The low depth-to-length ratio of the failure at this site suggests that the infinite slope stability theory might be applied. Assuming a depth no greater than one-twentieth the length, or about 3.5 feet, developed cohesion values of only 0.18 and 0.03 p.s.i. are necessary for stability in the absence of seepage forces, for  $\phi = 35^\circ$

and  $38^\circ$ , respectively. Under the extreme condition that would permit seepage throughout the fill, with a top flow line coincident with the fill slope, the necessary developed cohesion values would be 0.83 and 0.75 p.s.i. for  $\phi = 35^\circ$  and  $38^\circ$ , respectively. Such an extreme seepage condition seems unlikely at this site, although it has already been noted that water collected on the road at this location. It is possible, however, that water infiltrating from the road surface combined with the ground water, resulting in emergence of the water at some location above and near the toe of the fill slope. A subsequent "blow out," or quick condition might have occurred locally, and the resultant loss of support at the toe would have allowed the upslope material to slide.

In any case, the analyses of this site and of site 917-1 seem to indicate that a more realistic value for the friction angle in this material might be about  $38^\circ$ .
